MIL "ON" VVT-i DTCs - Oil Control Valve (OCV)

Service Category Engine/Hybrid System

Section Engine Control

Some 2005 – 2011 model year 2GR-FE equipped vehicles may exhibit a MIL "ON" condition with one or more VVT-i related Diagnostic Trouble Codes (DTCs) stored in the Engine Control Module or ECM (SAE term: Powertrain Control Module/PCM). Please use the following repair procedure to address this condition.

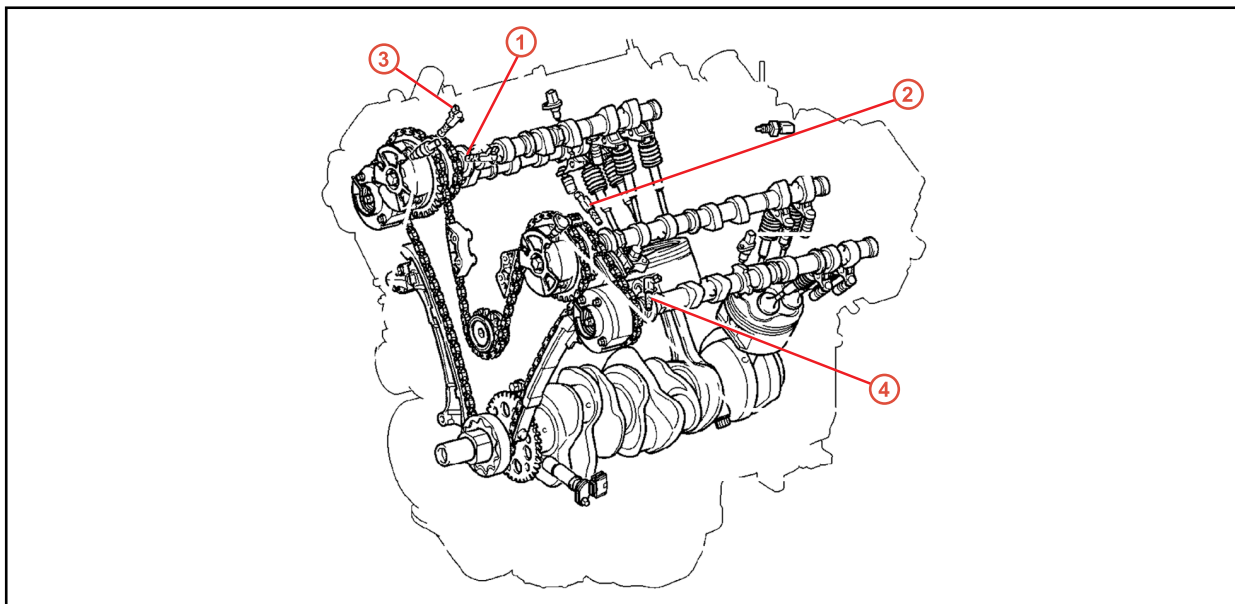
Figure 1.

1. Using TIS Techstream, confirm if any of the DTCs listed below are stored, remove the affected OCV, and visually inspect the spool valve for debris or sticking in its bore.

1	Bank 1 Intake Camshaft Timing OCV (RH)
2	Bank 2 Intake Camshaft Timing OCV (LH)

3	Bank 1 Exhaust Camshaft Timing OCV (RH)
4	Bank 2 Exhaust Camshaft Timing OCV (LH)

- If debris is present or the valve is sticking, proceed to step 3.

- Remove the valve cover from the affected bank and temporarily remove both OCVs.
