Subject		Market	
MIL "ON" DTC P0138 or P0138 with P0607		USA	
Service Category		Section	
Engine/Hybrid System		Engine Control	
Applicability			
09-10 MY Corolla

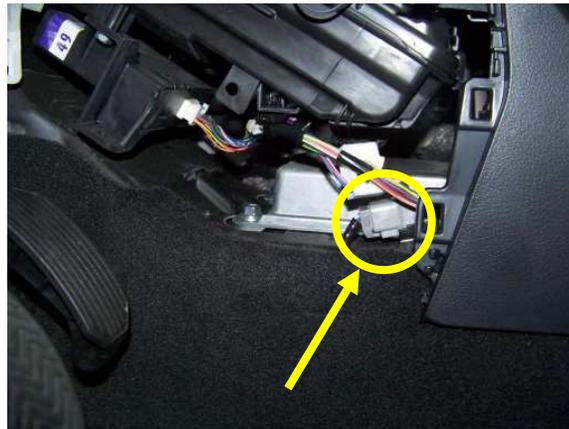
- If both DTCs P0138 and P0607 are stored, diagnose P0138 first.
- Follow Repair Manual procedure for DTC P0138. During diagnosis, the following may be helpful:
 - Check Freeze Frame Data.
 - An O2S B1S2 value of 1.27v indicates a short to a power source, such as the Bank One Sensor Two (B1S2) heater circuit.
 - If a short is suspected, visually inspect B1S2 connector E86, which is located behind the driver's side console box insert (to the right of the accelerator pedal), for signs of water intrusion.

HINT:
A restricted or blocked evaporator drain could cause this

- If water is found, diagnose the origin of the water and repair as necessary.
