2008 SEQUOIA

New Model Highlights

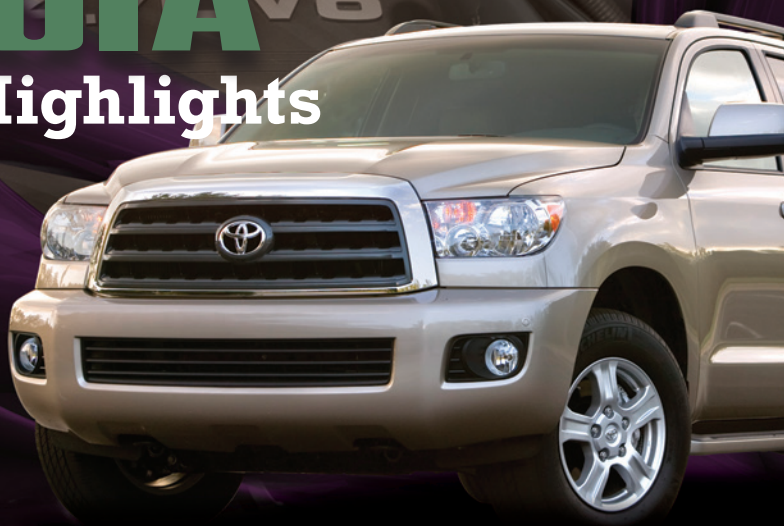
HEADLIGHT CLEANER SWITCH

From the front, you'll recognize the SUV's strong resemblance to the Tundra. A new feature is headlamp washers controlled by a switch mounted on the instrument panel, to the left of the steering wheel. A dedicated washer pump is attached to the shared washer bottle located beneath the hood. When the switch is activated, system pressure extends the washers to clean the headlamps.

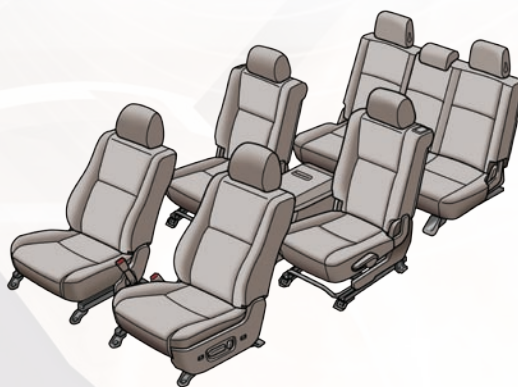
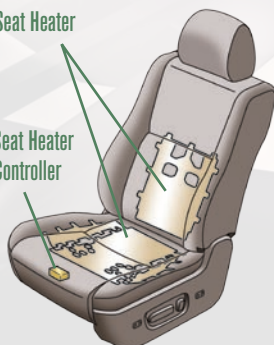
7-PASSENGER MODEL (WITH CONSOLE FOR REAR NO. 1 SEAT)

Seat Heater

Seat Heater
Controller

Blower Unit
(Seatback)

Blower Unit
(Seat Cushion)

The driver and front passenger seats are available with heating and ventilation. The second row seats are available with heaters.

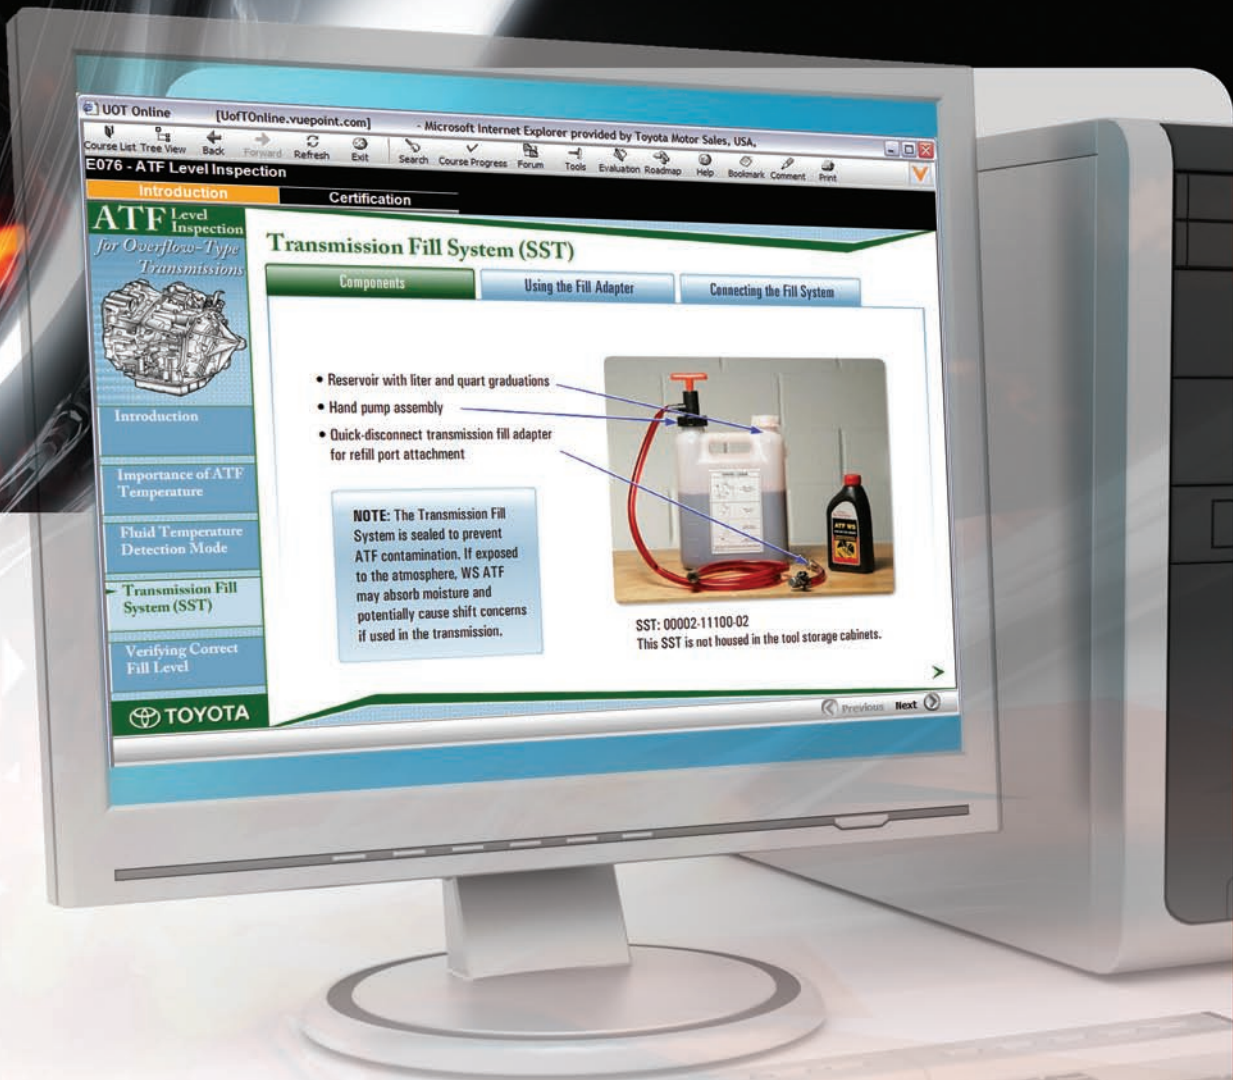
Essential Special Service Tool

The dipstick and tube for adding WS ATF to the transmission have been replaced with a refill plug and hole. This is a large, threaded hole that is usually located on the side of the transmission or transaxle case. Toyota has issued an essential Special Service Tool (SST) 00002-11100-02 for use with this refill hole. It has a quick disconnect fitting that is equipped with one-way valves to reduce spills and decrease the time it takes to complete the ATF level inspection procedure. All dealers should have this tool available for use. If not, contact SPX/OTC at 1-800-933-8335.

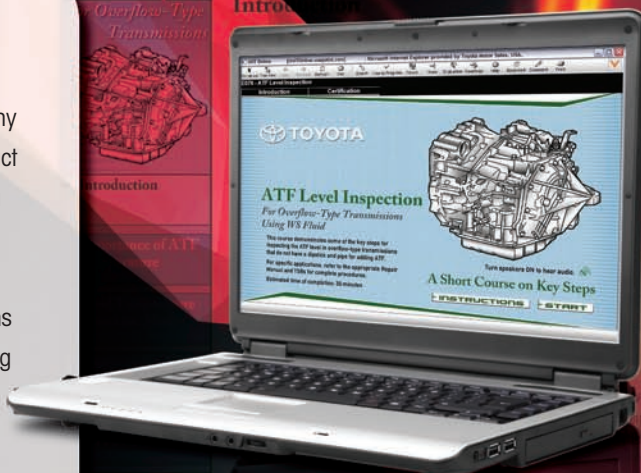
E076 – ATF Level Inspection Web Module

Because this procedure may be new to many technicians, the University of Toyota and Product Quality and Service Support recently released a web module (E076 – “ATF Level Inspection”) that explains the mechanics of the ATF level inspection process on overflow type transmissions and transaxles equipped with WS ATF. Following this procedure is critical — failure to do so could result in shift quality, MIL “ON” and/or transmission damage issues.

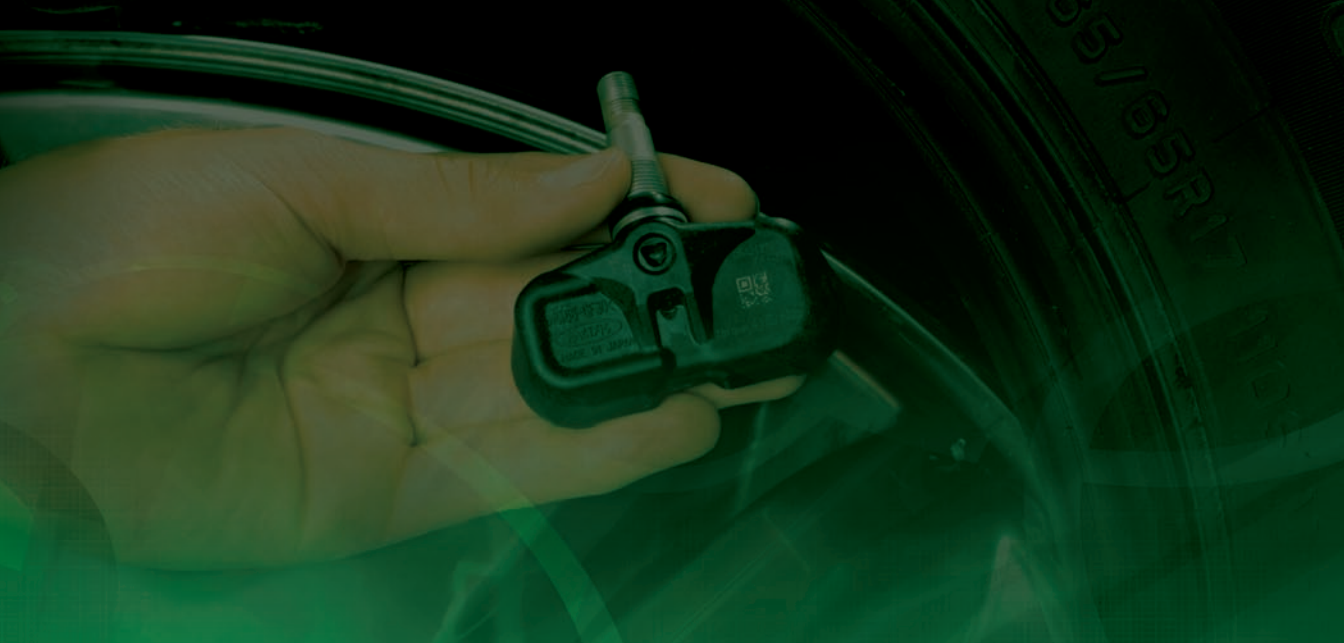
#	MODEL	MODEL YEAR	SYSTEM TYPE
1	4Runner	2004	DENSO Pacific
2	Tundra	2005 – 2006	
3	Sequoia	2005 – 2007	
4	Land Cruiser	2006 –	
5	Prius		
6	RAV4		
7	Tacoma		
8	Avalon	2007 –	
9	Camry		
10	Scion tC		
11	Solara		
12	Corolla	2008 –	
13	FJ Cruiser		
14	Highlander		
15	Highlander HV		
16	Matrix		
17	Scion xB		
18	Scion xD		
19	Yaris		
20	Sienna	2007 –	TRW
21	Tundra		
22	Sequoia	2008 –

New additions to the 2008 model year Direct Tire Pressure Warning System includes:

- TRW System (2007 to current model year Tundra and Sienna, and the new generation 2008 model year Sequoia).
- Reduction in the amount of time it takes to detect diagnostic codes; reduced from 51 minutes to 20 minutes key ON engine OFF (TRW system requires 20 minutes of consistent driving above 3 mph).
- Diagnostic Trouble Code C2126 – Transmitter ID not Received.

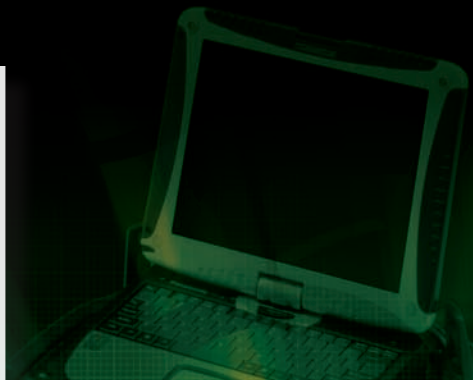
Reminder: When attempting to re-register the Tire Pressure Sensor ID Numbers using Techstream after a repair or tire and wheel swap, it may be necessary to jump terminals TC and CG at the DLC3 connector. 2006–2007 Land Cruiser vehicles require terminals TC and E1 at DLC1. The Techstream condition is shown below:

- >> Select "OK."
- >> Disconnect Techstream and jump terminals TC and CG at the DLC3 connector (for Land Cruiser: jump terminals TC and E1 at DLC1) for 15 seconds with the ignition "ON" and engine OFF.
- >> After 15 seconds, remove the jumper wire and reconnect Techstream to register the Tire Pressure Sensor ID numbers.
