Initialization of Rear View Monitor System

Service Category General

Section Pre-Delivery Service

YEAR(S)	MODEL(S)	ADDITIONAL INFORMATION
2011	Sienna

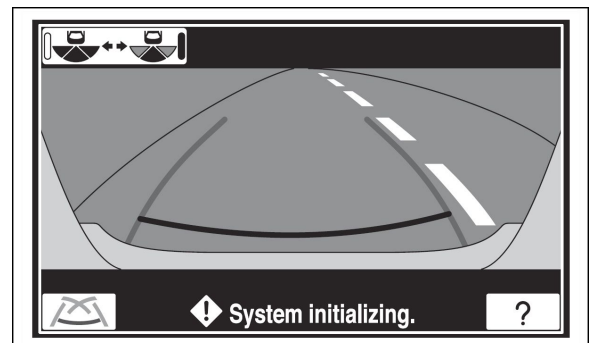
Figure 1. Before Initialization

As a result of the removal of the short pin, the power source to the steering angle sensor is cut off. When the short pin is reinstalled, the rear view monitor system will be operative, but it cannot display guide lines to assist parking operation because the center position is not recognized by the steering angle sensor. Please initialize the rear view monitor system after installing the short pin during PDS (Pre-delivery Service).

- A. Shift the shift lever to the "R" (reverse) position. If the rear view monitor appears as illustrated in Figure 1, please initialize the rear view monitor system.

2. Shift the shift lever to the "P" (park) position. Turn the steering wheel lock to lock.
3. Shift the shift lever to the "R" (reverse) position and touch the parallel parking mode switch on the screen. When the longitudinal guidelines and "Check surroundings for safety" appear on the rear view monitor as illustrated in Figure 2, the initialization of the parking assist monitor has been completed.
